# BELZONA® 4181 SOLVES NEUTRALIZATION PROBLEM

ID: 1161

Application: TCC-Tanks and Chemical Containment Areas

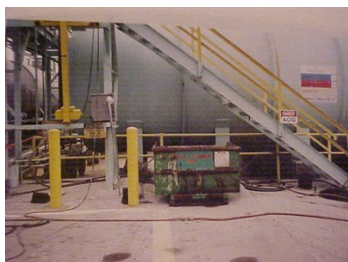
\* Overview of the sulfuric acid containment area , \* Deteriorated coating after the caustic was added to the acid spill , \* New concrete poured and pedestals coated with Belzona® 4311 , \* Finished project with Belzona® 4181 and perfect after 8 years ,

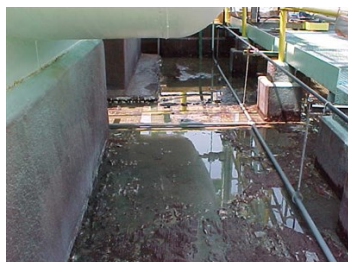
Spill of 98% sulfuric acid was neutralized with caustic. The exotherm badly damaged the coating applied 2 years previous.
