BELZONA SAVES MORE THAN 1 BILLION US DOLLARS

ID: 1165

Industry: *Fluid Flow*
Application: *CEP-Centrifugal Pumps*
Substrate: *Cast iron*
Products: ** Belzona® 1111 (Super Metal) ,*
** Belzona® 1311 (ceramic R Metal) ,*
** Belzona® 1321 (Ceramic S Metal) ,*

Customer Location: *Potash Producer, Jordan*
Application Date: *July 2008*

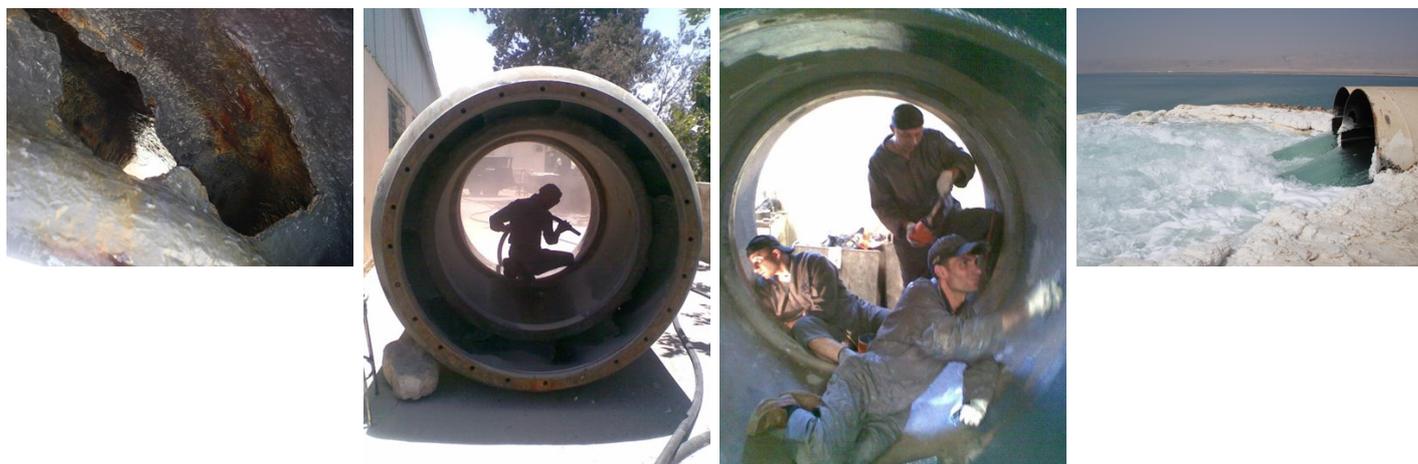
Photograph Descriptions

Extreme erosion & corrosion of the internal body. Fifteen vanes badly eroded.

- * Body & Vanes severely damaged ,
- * Application team at work after Blasting and Sweet Water washing for 6 days to remove heavy salt contamination ,
- * Final touch-up ,
- * Smooth operation after 2 months, pumping 18,000 Cu.m/hr ,

Diffuser end section from main intake lift pump station handling highly saline sea water.

Application was carried out in accordance with Belzona System Leaflets CEP-1, CEP-2, CEP-3, CEP-4, CEP-5 and CEP-6.
