# BELZONA SAVES MORE THAN 1 BILLION US DOLLARS

Application: CEP-Centrifugal Pumps

Customer Location: Potash Producer, Jordan

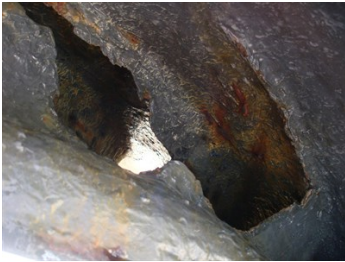
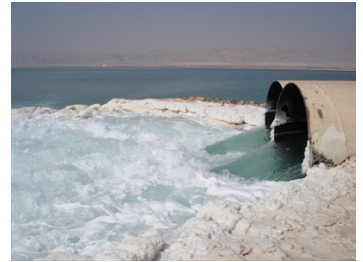
Extreme erosion & corrosion of the internal body. Fifteen vanes badly eroded.

- \* Body & Vanes severely damaged ,
- \* Application team at work after Blasting and Sweet Water washing for 6 days to remove heavy salt contamination ,
- \* Final touch-up ,
- \* Smooth operation after 2 months, pumping 18,000 Cu.m/hr ,

Diffuser end section from main intake lift pump station handling highly saline sea water.

Application was carried out in accordance with Belzona System Leaflets CEP-1, CEP-2, CEP-3, CEP-4, CEP-5 and CEP-6.

Importing new part would take minimum 6 months to deliver at a cost of \$500,000 and loss of production market value of \$933 millions. Belzona material and application cost was \$59,000 which equals 12% of the new part and 0,0006% of the production selling value.
