# BELZONA SAVES MORE THAN 1 BILLION US DOLLARS

ID: 1165

Industry: *Fluid Flow*  
Application: *CEP-Centrifugal Pumps*  
Substrate: *Cast iron*  
Products: *\* Belzona® 1111 (Super Metal) ,*  
*\* Belzona® 1311 (ceramic R Metal) ,*  
*\* Belzona® 1321 (Ceramic S Metal) ,*

Customer Location: *Potash Producer, Jordan*  
Application Date: *July 2008*

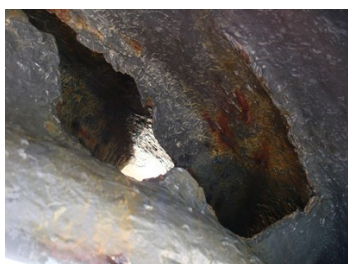
*Extreme erosion & corrosion of the internal body. Fifteen vanes badly eroded.*

- \* Body & Vanes severely damaged ,
- \* Application team at work after Blasting and Sweet Water washing for 6 days to remove heavy salt contamination ,
- \* Final touch-up ,
- \* Smooth operation after 2 months, pumping 18,000 Cu.m/hr ,
