BELZONA RECLAIMS AND PROTECTS SULFURIC ACID BUND

Customer Location: Sulfuric Acid Refinery, Wyoming U.S.A.
Application Date: September 2008

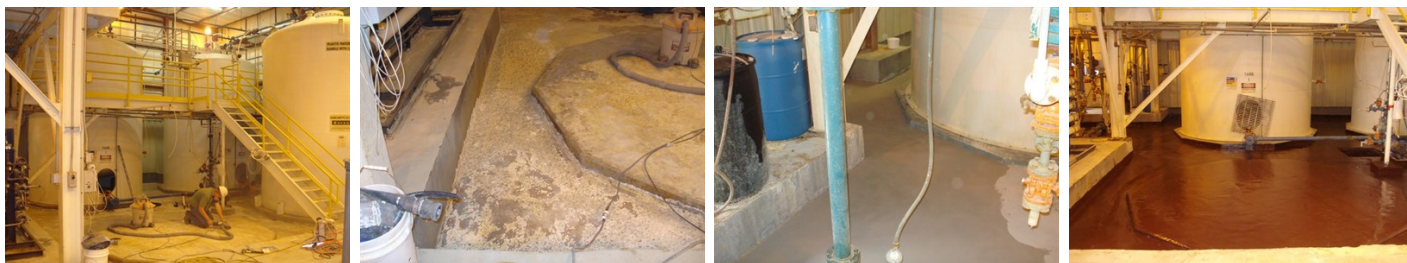
Photograph Descriptions

Previous product used gave limited results. Extensive rebuilding of the concrete was needed to allow the containment area to drain to the center sump. This to be followed by an overall protective coating.

- * Overview of the acid containment area ,
- * View of the damaged concrete ,
- * View of area rebuilt and resurfaced ,
- * Completed job after coating with Belzona 4311 ,

Application was carried out in accordance with Belzona Know-How System Leaflet TCC-9 & 15. Concrete was rebuilt to create falls to central sump. All area then protected with Belzona 4311.
