# BELZONA SAVES PUMP FROM THE SCRAP HEAP

ID: 1168

Industry: *Pulp & Paper*  
Application: *CEP-Centrifugal Pumps*  
Substrate: *Cast Iron*  
Products: *\* Belzona® 1311 (Ceramic R-Metal) ,*  
*\* Belzona® 1321 (Ceramic S-Metal) ,*

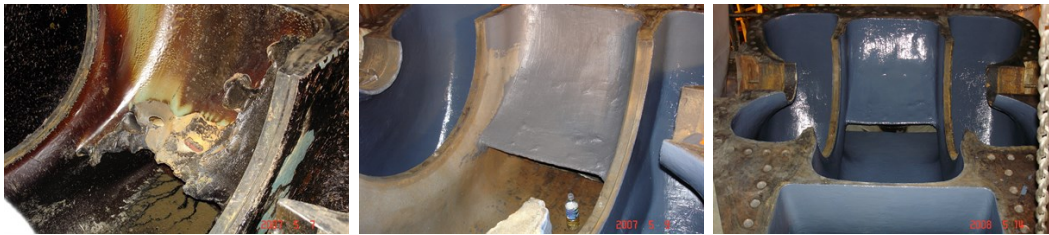
*Bad injectors had caused Sulfuric acid not to mix well with paper stock and pump was badly eroded. Cut-water on discharge was eroded away and bowl was severely pitted. Holes through pump bowl. After inspection, injectors were moved downstream.*

- \* Pump before repair ,
- \* Cut-water rebuild finished ,
- \* Completed application ,

Application was carried out in accordance with Belzona Know-How System Leaflet CEP-1, CEP-3 and CEP-5.

The customer saved around \$300,000.00 (US) with Belzona solution. After inspection 1 1/2 years later rebuild is still in good condition with no worn areas.
