# BELZONA GIVES SPIRAL CASING AND VANES NEW LEASE OF LIFE

ID: 117

Customer Location: *Hydroelectric Power Station in Japan*  
Application Date: *January 1996*

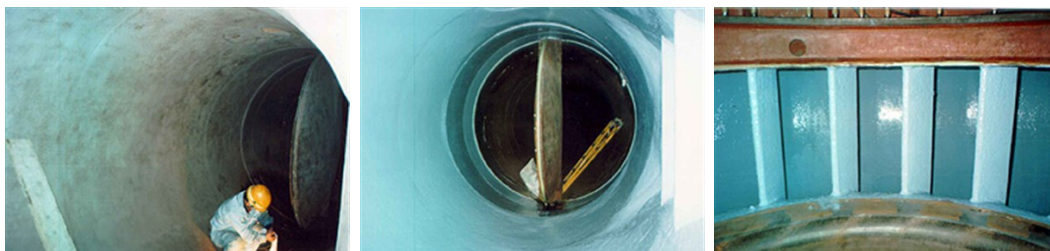
*Erosion/corrosion caused by river water.*

- \* Surface preparation underway in the spiral casing ,
- \* Casing coated with Belzona® 1341 ,
- \* Application completed by coating vanes ,

In accordance with Belzona Know-How Leaflet CEP-3. The casing and vanes were blast cleaned and the existing lining material (tar epoxy) peeled off. Belzona® 1341 was applied by airless spray. The coating was then tested for pinholes.
