# OLD APPLICATION MEETS NEW BELZONA APPLICATION

ID: 1174

Customer Location: Railroad in Saint Paul, Minnesota U.S.A.

Application: FPA-Floor Problem Areas

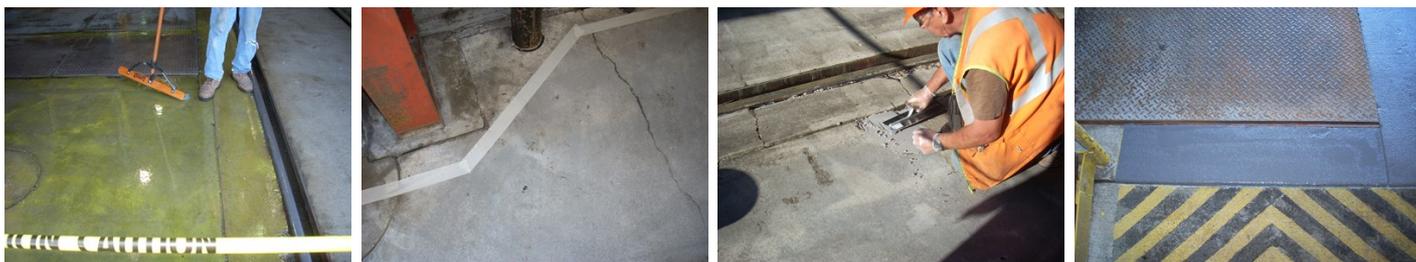
The floor gets covered in fuel and water causing a slip hazard. Also the cleaning method began attacking the concrete.

- \* Preparing the surface ,
- \* Taping off edges ,
- \* Patching holes before coating ,
- \* Old Belzona® 4411 on ramps meets new Belzona® 5231 on workshop floor ,

Applications was carried out in accordance with Belzona Know-How System Leaflets FPA-3 & FPA-8.

The ramps where done over 12 years ago and still in great condition saving time and money spent re-doing them repeatedly with systems. The floor has shown to be a safety benefit that also is easier and faster for crews to clean.
