OLD APPLICATION MEETS NEW BELZONA APPLICATION

ID: 1174

Industry: Buildings & Structures
Application: FPA-Floor Problem Areas

Customer Location: Railroad in Saint Paul, Minnesota U.S.A.
Application Date: 1996 and 2008

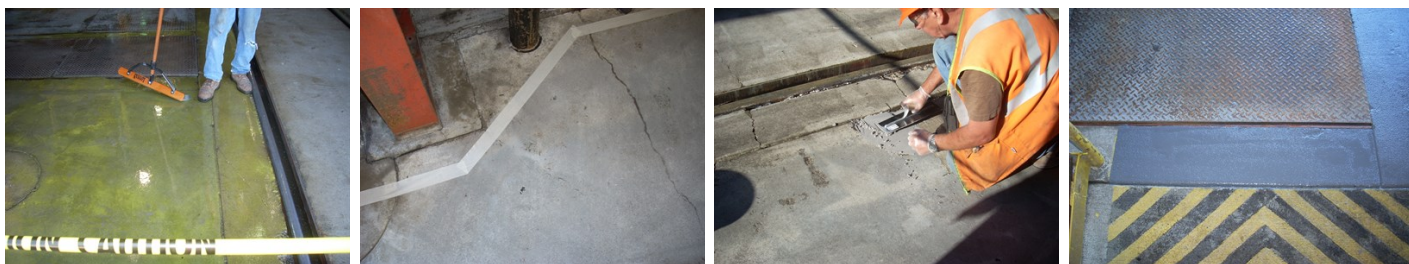
Photograph Descriptions

The floor gets covered in fuel and water causing a slip hazard. Also the cleaning method began attacking the concrete.

- * Preparing the surface ,
- * Taping off edges ,
- * Patching holes before coating ,
- * Old Belzona® 4411 on ramps meets new Belzona® 5231 on workshop floor ,

Applications was carried out in accordance with Belzona Know-How System Leaflets FPA-3 & FPA-8.

The ramps where done over 12 years ago and still in great condition saving time and money spent re-doing them repeatedly with systems. The floor has shown to be a safety benefit that also is easier and faster for crews to clean.
