BELZONA SEALS PACKING FACILITY

ID: 1175

Industry: *General Industry*
Application: *RPA-Roof Problem Areas*
Substrate: *Aluminum*
Products: *Belzona® 3111 (Flexible Membrane)*

Customer Location: *Cement Company, Miami, Florida U.S.A.*
Application Date: *April 2008*

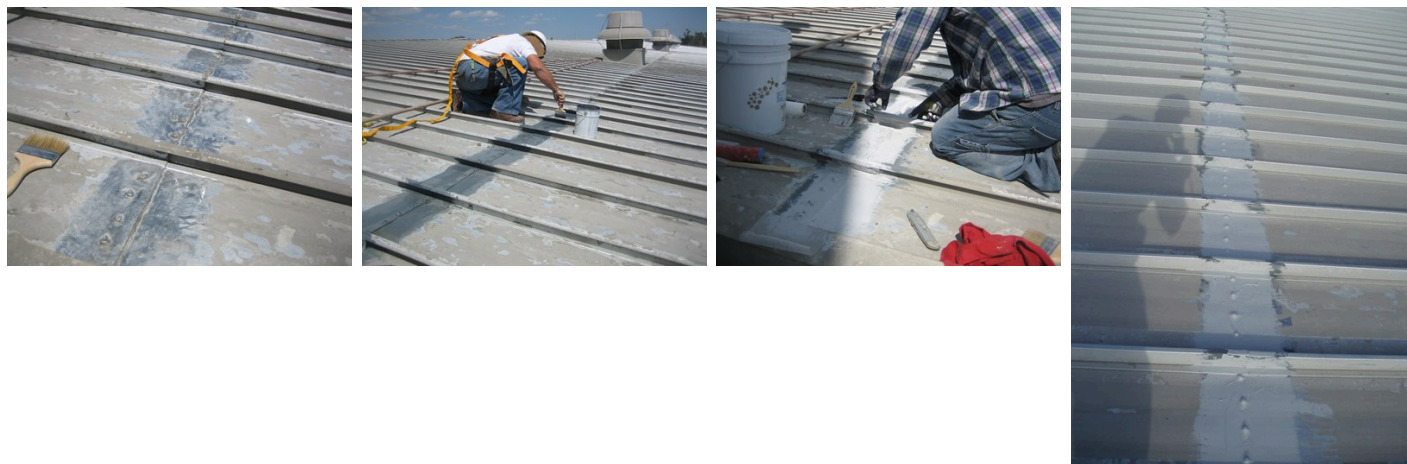
Photograph Descriptions

Roof was leaking through the seams and joints.

* Uncoated seams , * Belzona® 3921 (GSC Conditioner) being applied , * Seams being coated with Belzona® 3111 and reinforced with Belzona® 9311 , * Finished application. ,

Bolted metal roof

Application was carried out in accordance with Belzona Know-How System Leaflet RPA-1.

The customer was previously using a low cost silicone sealant with poor results allowing continued damage to expensive packing machinery and controls.
