# VERY OLD BELZONA TUBE SHEET REPAIR

**Customer Location:** Petrochemical Plant, Plaquemine,  
Louisiana U.S.A.

**Application:** HEX-Heat Exchangers

**Application Date:** January 1973

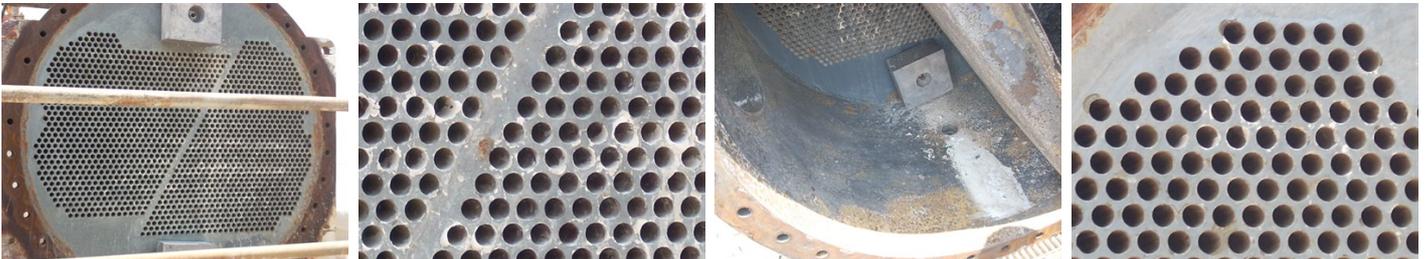
## Photograph Descriptions

The tube sheet was suffering from bi-metallic corrosion and was in need of protection.

- \* Rear of Condenser ,
- \* Close up of sheet ,
- \* Front of Condenser ,
- \* Close up of sheet ,

This carrier condenser was coated in order to prolong the life of the unit.

The application was carried out in accordance with Belzona Know-How System Leaflet HEX-1.

This application occurred in 1973, which makes this a successful repair that is 35 years old. Replacement costs for a new unit is approximately \$350,000, and a Belzona repair today would cost the customer about \$25,000. For this one low cost, the customer saved replacement costs and downtime for many years. This particular unit is set for retirement in a January 2009 turnaround.
