# BELZONA PROTECTS LARGE RIVER PUMP

ID: 1179

Application: CEP-Centrifugal Pumps

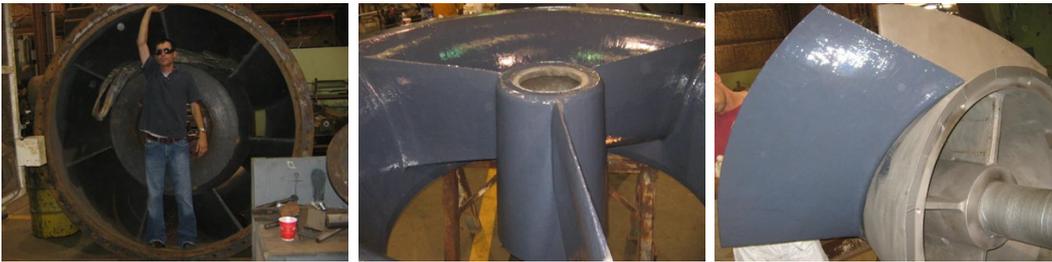
Pump was subject to erosion due to solids drawn from the river.

- \* Scale of the pump clearly evident ,
- \* Fully restored suction diffuser ,
- \* Work beginning on restoration of impeller ,
- \* Fully protected impeller ,

The cost of a replacement pump is \$250,000 and delivery time from the manufacturer is 6 months. Belzona was able to repair the pump and have it back in service within a week and will last longer than a new pump due to the erosion corrosion resistance of Belzona® 1321.
