BELZONA REBUILDS AND PROTECTS EXHAUST ON YACHT

ID: 1181

Customer Location: Shipyard, Monaco

Application Date: November 2008

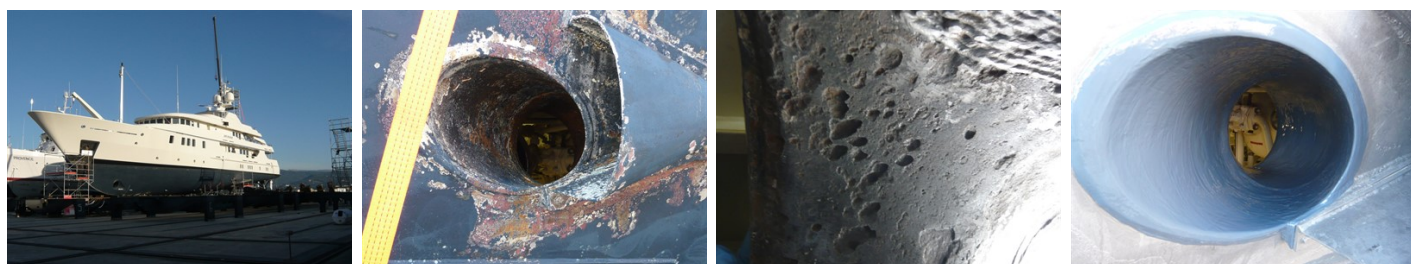
Photograph Descriptions

Severe corrosion caused by hot exhaust gas and salt water, led to critical loss of steel.

* The yacht in dock , * Initial state of exhaust pipe , * Pitting clearly evident after blasting , * Final result after rebuilding with Belzona® 1511 and coating with Belzona® 1391 ,

Application was carried out in accordance with Belzona Know-How System Leaflets SOS-1 & -2.

This repair was completed in 2 days.
