BELZONA REBUILDS AND PROTECTS EXHAUST ON YACHT

ID: 1181

Industry: Marine

Application: SOS-Ships and Offshore Structures

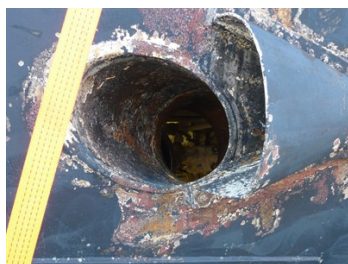
Severe corrosion caused by hot exhaust gas and salt water, led to critical loss of steel.

* The yacht in dock , * Initial state of exhaust pipe , * Pitting clearly evident after blasting , * Final result after rebuilding with Belzona® 1511 and coating with Belzona® 1391 ,
