# BELZONA REBUILDS AND PROTECTS EXHAUST ON YACHT

Customer Location: Shipyard, Monaco

Application: SOS-Ships and Offshore Structures

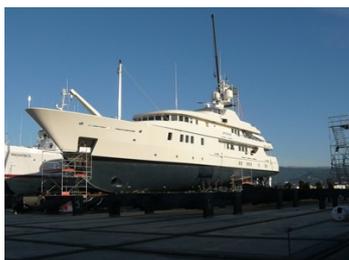
Severe corrosion caused by hot exhaust gas and salt water, led to critical loss of steel.

\* The yacht in dock , \* Initial state of exhaust pipe , \* Pitting clearly evident after blasting , \* Final result after rebuilding with Belzona® 1511 and coating with Belzona® 1391 ,
