BELZONA RESTORES AND PROTECTS RIVER WATER PUMP

ID: 1182

Customer Location: Petrochemical Plant, Louisiana U.S.A.

Application: CEP-Centrifugal Pumps

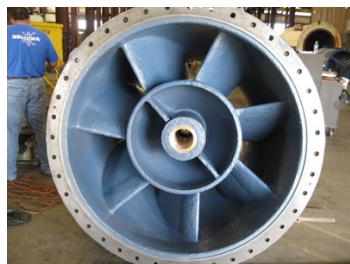
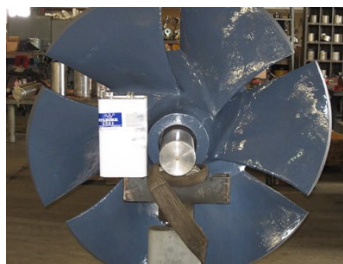
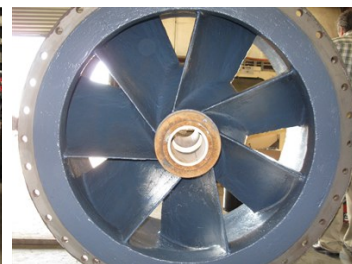
Pump was experiencing corrosion and cavitation erosion damage. Much of the casing was suffering from pitting caused by impingement.

* Rebuilt and protected suction bell , * Impeller with first coat of Belzona® 1321(Grey) , * Impeller fully protected with second coat Belzona® 1321 , * Suction diffuser fully restored ,

Application was carried out in accordance with Belzona Know-How System Leaflets CEP-1, -3 and -5.
