BELZONA RESTORES AND PROTECTS RIVER WATER PUMP

Customer Location: Petrochemical Plant, Louisiana U.S.A.

Application: CEP-Centrifugal Pumps

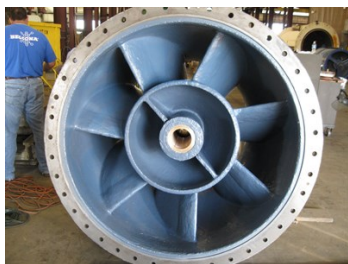
* Rebuilt and protected suction bell , * Impeller with first coat of Belzona® 1321(Grey) , * Impeller fully protected with second coat Belzona® 1321 , * Suction diffuser fully restored ,

Application was carried out in accordance with Belzona Know-How System Leaflets CEP-1, -3 and -5.
