BELZONA® 1511/1591 TAKE THE HEAT

ID: 1183

Customer Location: Tennessee Valley Authority, North Alabama U.S.A.

The LP turbine flange on a steam generator turbine.

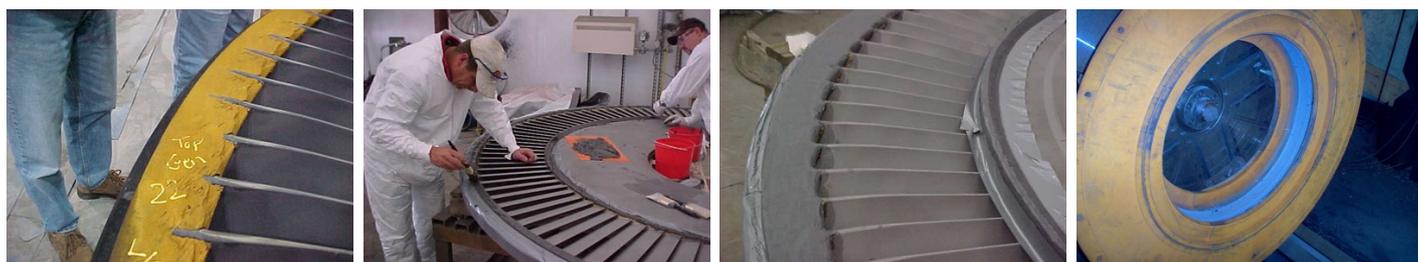
Photograph Descriptions

Steam cuts in the metal diaphragm. Welding would distort the flange and a short outage caused them to come to Belzona for an unconventional alternative.

* Eroded flange before repairs , * Belzona® 1511 being used to build back the edges and steam cut areas , * Belzona® 1511 built back to original profile and ready to machine , * Belzona® 1591 coated after the two pieces put together for machining ,

Belzona® 1511 used to rebuild damage (up to 1/2"), then machined to profile before coating with Belzona® 1591.

Time for welding was too long. Welding may distort the flange. Belzona 10% the cost of the alternative. After five years it was inspected and only minor touch up required.
