BELZONA PROTECTS CONDENSOR JOINT FOR TWENTY YEARS

ID: 1184

Customer Location: Nuclear Plant, USA
Application Date: 1989

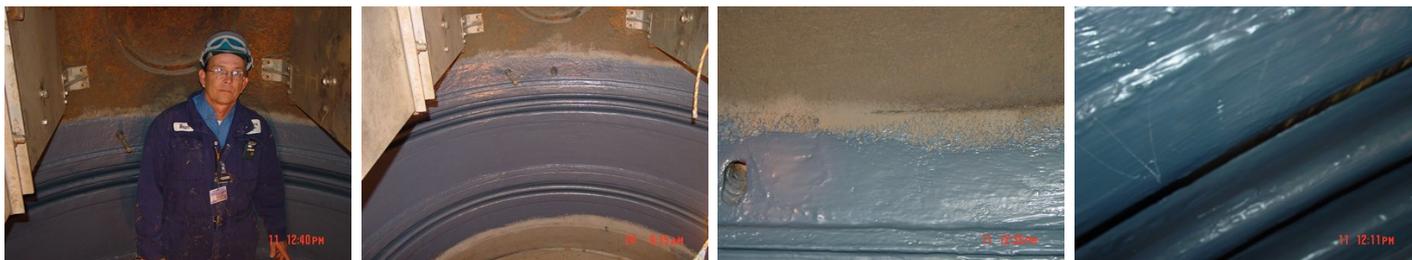
Photograph Descriptions

Joints could not be replaced in the short nuclear plant refueling outage. Corrosion had caused holes in the metal expansion joints.

* The original repair , * Overall view of the repair , * Rebuild with Belzona® 1311 , * Two coats of Belzona® 1321 applied over the joints ,

Carbon Steel expansion joints below the condenser corroding due to bimetallic corrosion.

First repair lasted 20 years. Although the unit had been down 10 of those years. When the unit was restarted the engineers inspected the old Belzona and found it in excellent shape with only minor damage. It was decided to remove the old Belzona and rework the project. A dozen joints were repaired and coated.
