# BELZONA PROTECTS CONDENSOR JOINT FOR TWENTY YEARS

Customer Location: Nuclear Plant, USA

Application: VPF-Valves, Pipes and Fittings

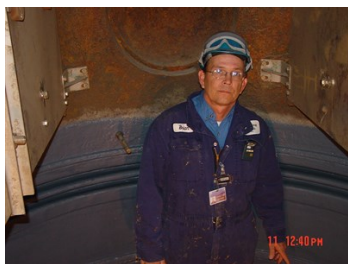
Joints could not be replaced in the short nuclear plant refueling outage. Corrosion had caused holes in the metal expansion joints.

\* The original repair , \* Overall view of the repair , \* Rebuild with Belzona® 1311 , \* Two coats of Belzona® 1321 applied over the joints ,

First repair lasted 20 years. Although the unit had been down 10 of those years. When the unit was restarted the engineers inspected the old Belzona and found it in excellent shape with only minor damage. It was decided to remove the old Belzona and rework the project. A dozen joints were repaired and coated.

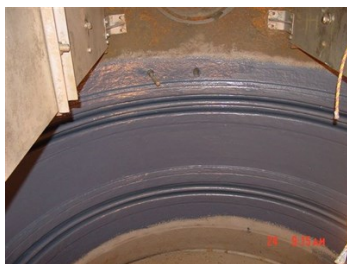
Carbon Steel expansion joints below the condensor corroding due to bimetallic corrosion.
