# BELZONA ALTERNATIVE TO HARD FACE WELDING

ID: 1186

Application: *SHM-Solids Handling Machinery*

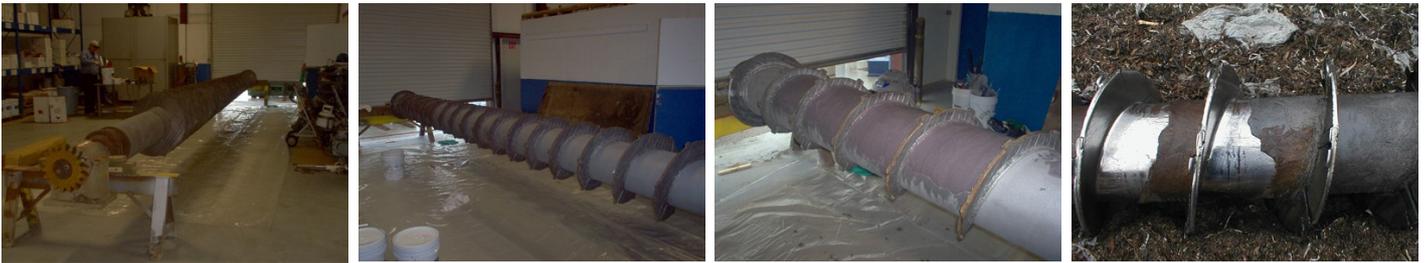
- \* Overall view of the 40 ft screw conveyor ,
- \* Screw conveyor with Belzona® 1812 applied ,
- \* Close up of the Belzona lining ,
- \* After 5 years, 75% still OK and was repaired in place ,

A 40 ft screw conveyor handling bark and ash.

*A new screw conveyor was fabricated and the client required lining to give greater abrasion resistance.*

Application was carried out in accordance with Belzona Know-How System leaflet SHM-14

Belzona lasted for over 5 years where the hard facing lasted about the same but was twice the price. Belzona® 1812 can be repaired in place but not hard face welding.
