BELZONA SEALS CHEMICAL BUNKERS FROM THE ENVIRONMENT

ID: 1187

Customer Location: Fertilizer Plant, North Alabama USA
Application Date: 1999

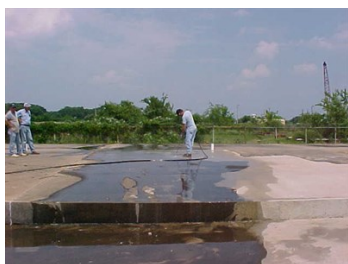
* Cleaning the concrete , * Overall view of cracks conditioned with Belzona® 3911 , * Joints and cracks sealed with Belzona® 3111 , * Spraying coat of clear cladding ,

Application was carried out in accordance with a modified Belzona Know-How System Leaflet RPA-1. Surface prepared by pressure washing then all cracks and joints sealed with Belzona® 3111 system. A coat of clear cladding was applied over the entire concrete storage area.
