# NO FLOOR? NO PROBLEM FOR BELZONA

Industry: Oil & Gas  
Application: HEX-Heat Exchangers  
Substrate: Galvanized Sheet Metal  
Products: Belzona® 1121 (Super XL Metal) Belzona® 5811 (Immersion Grade) Belzona® 3121 (MR-7)

Customer Location: Industrial Gas Producer, North Alabama  
Application Date: 2005

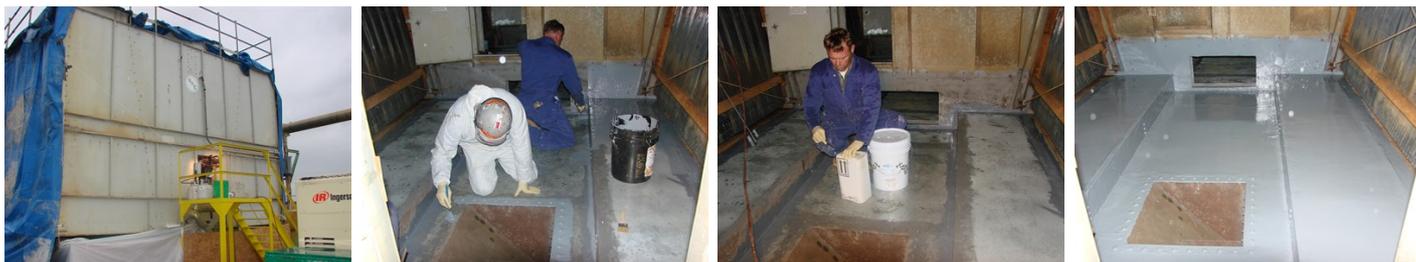
Floor was corroded badly and needed replacing during an outage.

\* Cooling tower protected from the weather , \* Sealing the seams with Belzona® 3121 , \* First coat of Belzona® 5811 being applied , \* Completed application ,

Cooling Tower Floor was corroded away.

Application was carried out in accordance with Belzona Know-How System Leaflets HEX-12 and GSS-3. The floor was abrasive blasted and new sheet metal cold plate bonded in place with Belzona® 1121. The seams were sealed with Belzona® 3121. Two coats of Belzona® 5811 were applied over the cold well surfaces.
