10 YEARS ON BELZONA® 4131 KEEPS ON PROTECTING

Customer Location: Power Plant, Central Alabama U.S.A.

Application: TCC-Tanks and Chemical Containment Areas

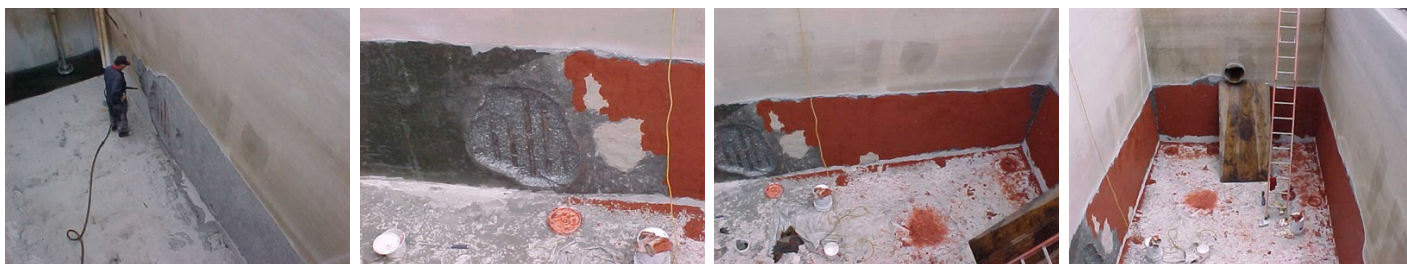
Photograph Descriptions

Chemicals had attacked the old lining and the concrete had deteriorated behind the fiberglass lining. Environmental contamination about to occur.

* Overview of the deterioration exposed during surface preparation , * One hole of 6 inches in depth , * & 4 Applying Belzona® 4131 ,

Neutralization Basin for a Power Plant was getting attacked by the acid/ caustic mixture.

Application was carried out in accordance with Belzona Know-How System Leaflet TCC-9.

Belzona was still protecting the pit beside this one for ten years. When a competitors material failed Belzona was selected to repair this basin. This basin is now ten years old and the second pit is still perfect over 19 years on.
