BELZONA KEEPS AIRPORT SAFE FOR TRAVELLERS

ID: 1196

Application: *FPA-Floor Problem Areas*

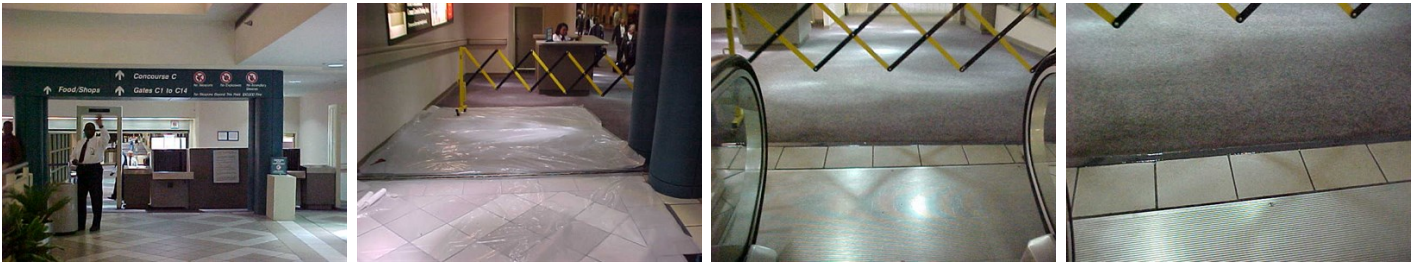
Old sealant was coming out of the joints. Steel plates over the joints did not alleviate the safety concerns.

- * The passenger terminal ,
- * One of the application areas ,
- * Problem joint in front of escalator ,
- * Completed Belzona® 2221 application ,

Expansion joints in passenger terminal.

Application carried out in accordance with Belzona Know-How System Leaflet FPA-6.

Joints still in service after 8 years. Excellent adhesion ensures no trip hazard created by failed sealant.
