BELZONA REPAIRS PARKING DECK EXPANSION JOINTS

Customer Location: International Airport, Alabama USA

Application: FPA-Floor Problem Areas

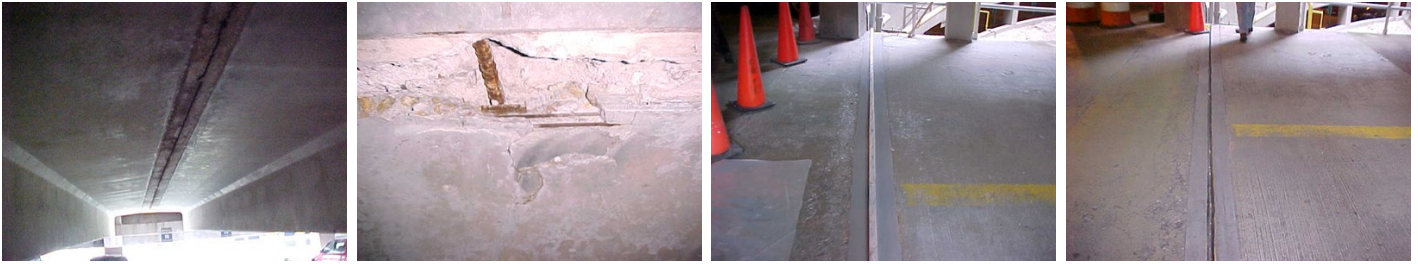
Photograph Descriptions

Sealant was failing and the concrete was deteriorated on each side of the joint on various levels of the parking deck. Fabricated expansion joints to be installed due to extreme movement.

* View of expansion joint from the floor below , * Spalled concrete due to water penetration and corrosion of rebar , * Forming the Belzona® 4111 using a 2" x 4" batten , * Repair after the expansion joint was installed ,

Application was carried out in accordance with Belzona Know-How System Leaflet FPA-5. Joint nosings were rebuilt with Belzona® 4111 prior to bonding prefabricated expansion joints in with Belzona® 4911.

Belzona® 4111 was used to repair the concrete due to the quick cure times. Belzona was also used due to superior adhesion in bonding the fabricated expansion joint. Repair has been excellent since 2000.
