BELZONA REFURBISHES LOADER

ID: 1199

Application: *MPT-Mechanical Power Transmission*

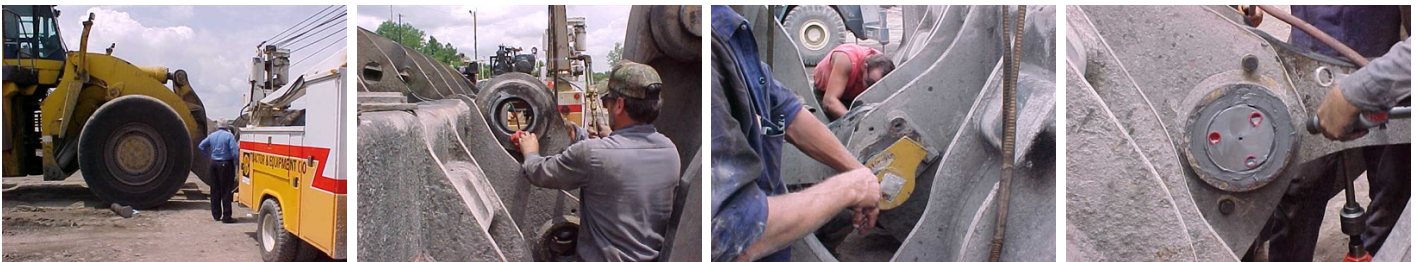
Photograph Descriptions

Sloppy pin fit allowed too much movement in the bucket arm. The bushing wore away allowing metal damage and lifting problems.

- * Overall view of the loader ,
- * Worn pin fit ,
- * Aligning the new bush ,
- * Final repair after new bushing is inserted ,

Loader lost a grease fitting and lack of regular lubrication resulted.

Application was carried out in accordance with Belzona Know-How System Leaflet MPT-7. The new bushing was used to form the new pin fit with Belzona® 1111.

Line Boring the fits was over \$3000. The Belzona repair was less than \$500. Repair lasted over 5 years. The repair was completed in a 5 hour period while the alternative was a weeks downtime
