# BELZONA REFURBISHES LOADER

Customer Location: *Heavy plant manufacturer, Alabama  
USA*

Application: *MPT-Mechanical Power Transmission*

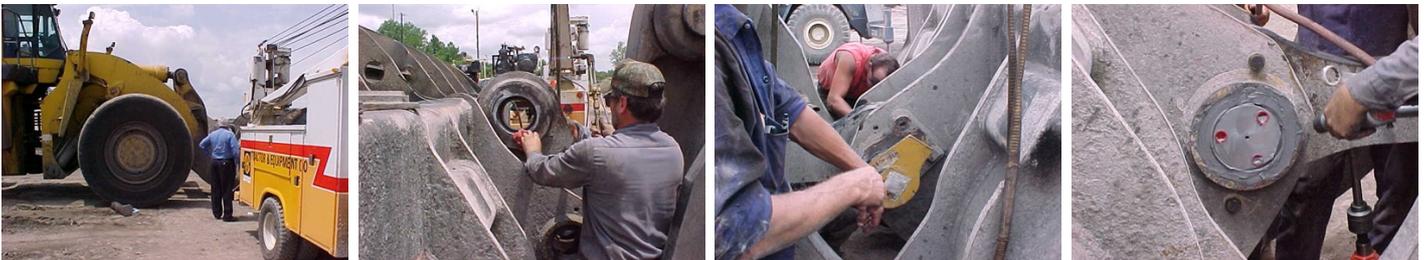
*Sloppy pin fit allowed too much movement in the bucket arm. The bushing wore away allowing metal damage and lifting problems.*

- \* Overall view of the loader ,
- \* Worn pin fit ,
- \* Aligning the new bush ,
- \* Final repair after new bushing is inserted ,

Loader lost a grease fitting and lack of regular lubrication resulted.

Application was carried out in accordance with Belzona Know-How System Leaflet MPT-7. The new bushing was used to form the new pin fit with Belzona® 1111.
