BELZONA SOLVES PROBLEM WITH AGITATOR BLADES

ID: 120

Customer Location: *Sugar Beet Mill in Italy*
Application Date: *1992*

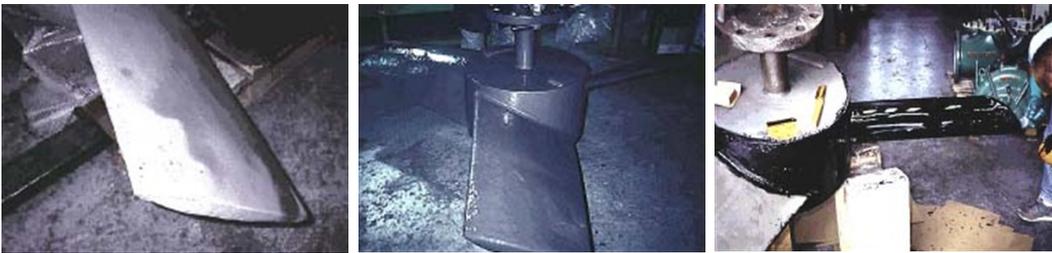
Photograph Descriptions

Abrasive solids in settling tank caused erosion on the surface of the agitator blades.

- * Damaged base of agitator. ,
- * Blades rebuilt with Belzona® 1000 Series product. ,
- * Application of Belzona® 2000 Series product. ,

The application was carried out in accordance with a modified version of Belzona Know-How Leaflet FBC-1.

When damage is due primarily to abrasion, the recommended solution is to rebuild and coat with the Belzona® Ceramic Metal System respectively. The Belzona® 2000 Series Elastomeric Polymers also may be used when impact and abrasion are the contributing factors.
