BELZONA ANCHORS THE TRACK

ID: 1202

Customer Location: *Steel Plant, North Alabama USA*
Application Date: *2002*

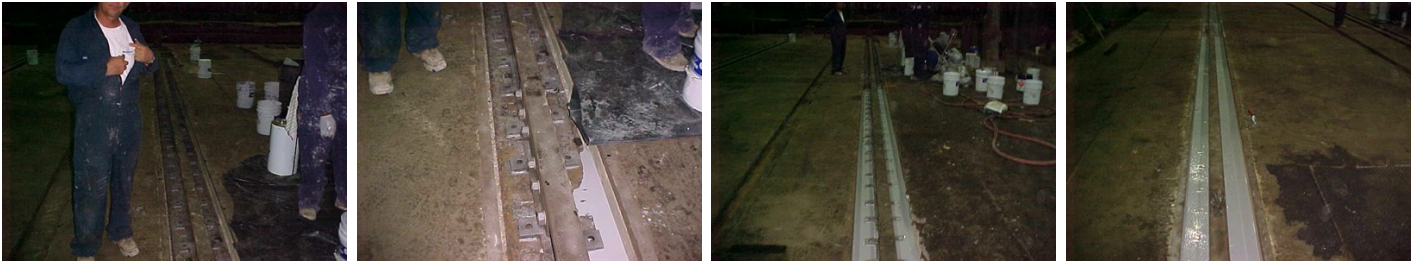
Photograph Descriptions

* After surface preparation , * Pouring the Belzona slurry , * grouting almost complete , * Completed project ,

Grout had failed around the blast furnace rails

Application was carried out in accordance with modified Belzona Know-How System Leaflet FPA-10. The old grout was removed and the rail was aligned and shimmed. A slurry mix of Belzona® 4111 was poured the length of the tract.

The fast cure times allowed the mill to be operational within ten hours. Other grouts needed days for cure.
