# BELZONA PROTECTS BLAST FURNACE SCRUBBER

ID: 1203

Industry:	General Industry	Customer Location:	Steel Plant, Alabama
Application:	TCC-Tanks and Chemical Containment Areas	Application Date:	2005
Substrate:	steel		
Products:	Belzona® 1321 (Ceramic S Metal)<div>Belzona® 1341 (Supermetalgilde)</div><div>Belzona® 5811 (Immersion Grade)</div>

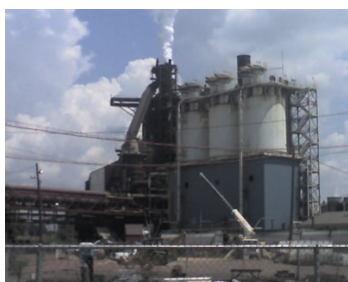
\* Overview of the blast furnace and the scrubber , \* Beige Belzona® 5811 applied and Belzona® 1341 and darker blue Belzona® 1321 being applied , \* Spark testing the Belzona® 1341 , \* View of the completed project ,
