BELZONA BRIGHTENS UP HOSPITAL LAUNDRY FLOOR

ID: 1205

Industry: *Buildings & Structures*
Application: *FPA-Floor Problem Areas*
Substrate: *Concrete*
Products: *Belzona® 5231 (SG Laminate)*

Customer Location: *Medical Center, Anniston, Alabama USA*
Application Date: *December 2007*

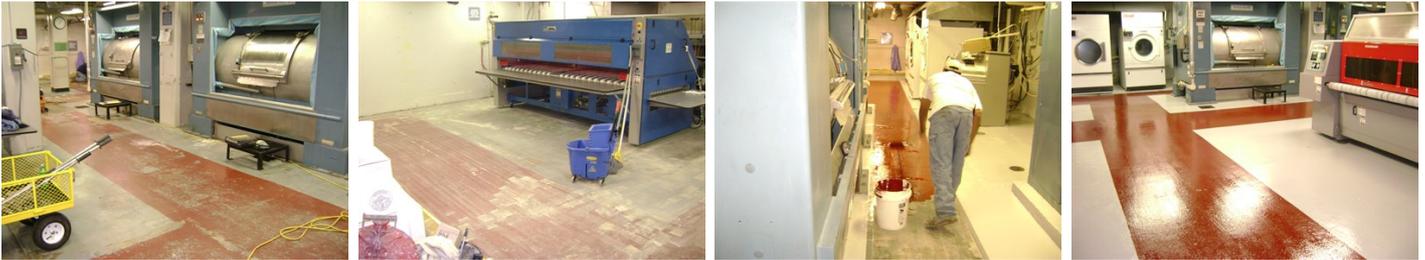
Photograph Descriptions

The coating that was currently on the floor was worn and causing slip hazards for the employees.

* Floor prior to being prepared , * Floor after being abraded , * Belzona® 5231 being applied , * Completed floor ,

Application was carried out using a modified Belzona Know-How System Leaflet FPA-3. The concrete was abraded to remove the existing coating and profile the concrete. Areas masked off and Belzona® 5231 Red and Gray used for demarcation.
