BELZONA EXTENDS LIFE OF COOLING TOWERS

ID: 1208

Customer Location: Bank, Birmingham, Alabama USA

Application: TCC-Tanks and Chemical Containment Areas

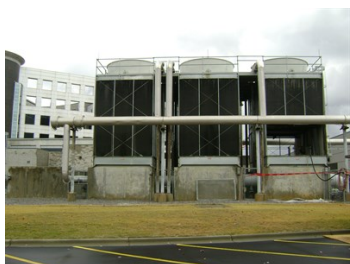
Chemicals used in water treatment had eaten the galvanizing off the sheet metal on the cooling tower pans. Pans needed to have the seams sealed and pans coated to prevent corrosion.

* Marley Cooling Towers at the Bank , * Belzona® 3121 with Reinforcement Sheet being applied to seams , * & 4. Completed application ,
