# BELZONA EXTENDS LIFE OF COOLING TOWERS

ID: 1208

**Customer Location:** Bank, Birmingham, Alabama USA

**Application:** TCC-Tanks and Chemical Containment Areas

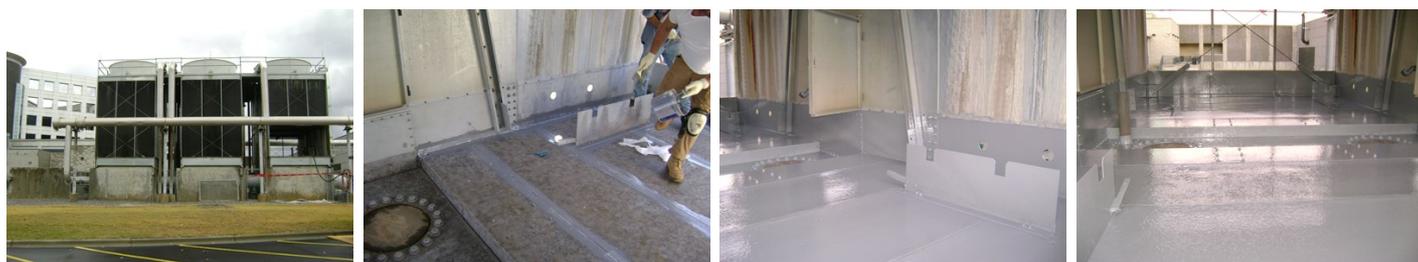
## Photograph Descriptions

Chemicals used in water treatment had eaten the galvanizing off the sheet metal on the cooling tower pans. Pans needed to have the seams sealed and pans coated to prevent corrosion.

\* Marley Cooling Towers at the Bank , \* Belzona® 3121 with Reinforcement Sheet being applied to seams , \* & 4. Completed application ,

Application was carried out in accordance with Belzona Know-How System Leaflets TCC-5 & RPA-1. Surfaces were abrasive blasted. Perimeter of pans and seams were sealed with Belzona® 3121. Belzona® 5811 applied to the entire interior surface of pans.
