# BELZONA COATS CROSSOVER FLOOR

ID: 1209

Industry: Buildings & Structures  
Application: FPA-Floor Problem Areas  
Substrate: Concrete  
Products: Belzona® 5231 (SG Laminate)

Customer Location: Car Manufacturing Plant, Alabama USA  
Application Date: October 2007

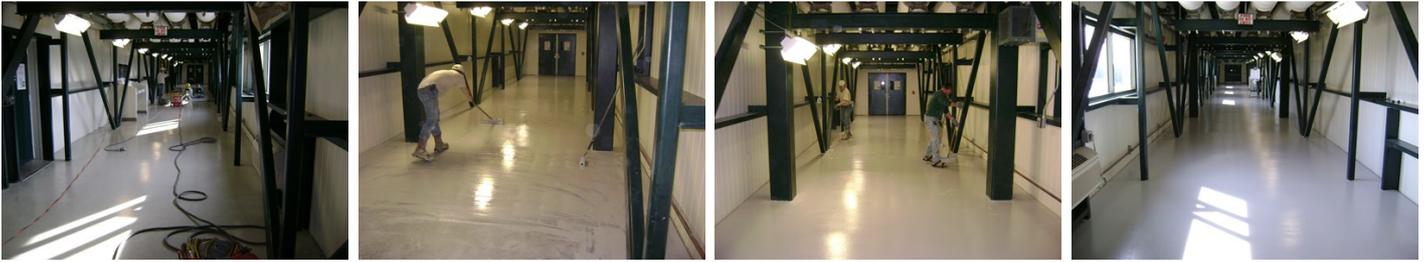
Previous floor coating was not bonded well in many places and needed to be replaced. This is a high traffic interior crosswalk in the plant and needed a non-slip surface.

\* Removing the existing floor coating , \* Applying first coat of Belzona® 5231 , \* Applying second coat of Belzona® 5231 , \* Completed application ,

Application was carried out in accordance with Belzona Know-How System Leaflet FPA-3. Existing coating was removed using a walk behind floor grinder before applying the Belzona® 5231 system. applicators used spiked boots to aid access.

Belzona® 5231 was chosen because the plant was familiar with many of our products already used in the plant. We were also the best option because of the quick cure time. The application started on Friday evening and floor was prepared, two coats of Belzona® 5231 applied and have them walking on it first thing Monday morning.
