BELZONA PROTECTS CONCRETE IN DAIRY

Industry: *Buildings & Structures*
Application: *FPA-Floor Problem Areas*
Substrate: *Concrete*
Products: *Belzona® 4311 (Magma CR-1)*

Customer Location: *Dairy plant, South Louisiana U.S.A.*
Application Date: *March 2004*

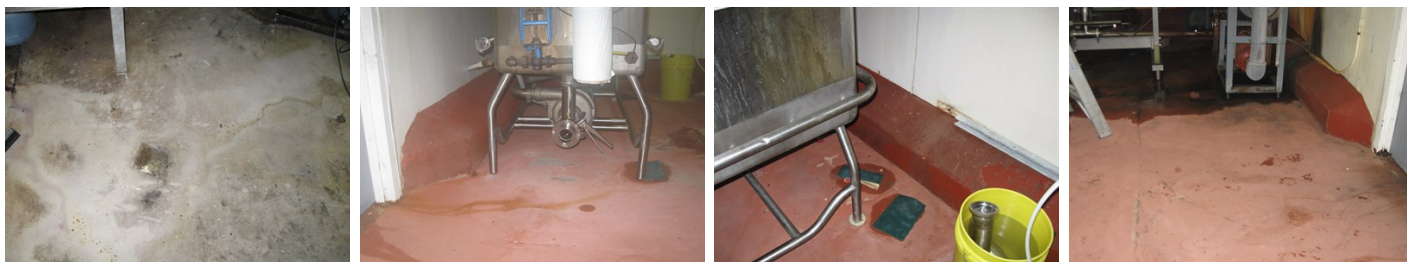
Photograph Descriptions

Customers concrete flooring was suffering from erosion due to chemical attack. Acidic cleaners are used in vessels and are drained onto the floors.

* Original substrate , * Completed coating around process vessel , * Complete coating on opposite wall , * Coating in front of door which endures heavy traffic ,

Repair and protect concrete floors inside of process unit.

Application was carried out in accordance with Belzona Know-How System Leaflet FPA-3.
