# BELZONA SAVES MILLIONS IN DOWNTIME

ID: 1214

Industry: *Chemical & Petrochemical*  
Application: *TCC-Tanks and Chemical Containment Areas*  
Substrate: *Carbon steel*  
Products: *Belzona® 1121 (Super-XL Metal)*

Customer Location: *Plastics Plant, Louisiana U.S.A.*  
Application Date: *May 2008*

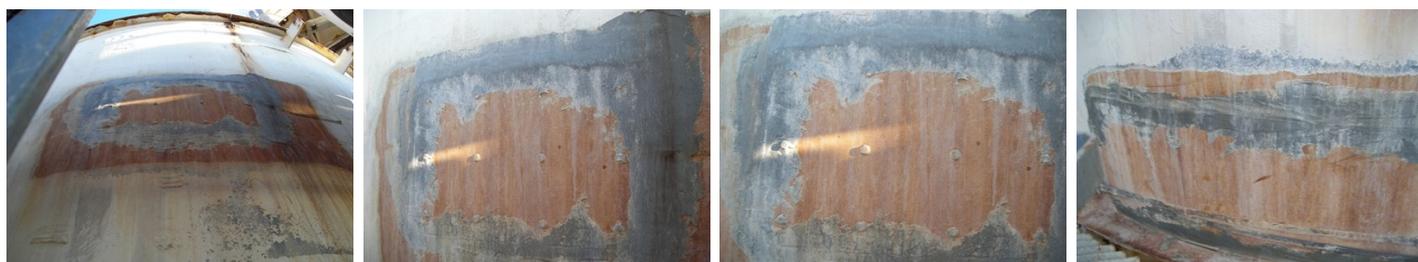
## Photograph Descriptions

*The vessel had been in service for over 20 years. It was suffering from severe corrosion and began to "rust through" in several places, causing the customer to become wary of complete failure.*

\* View of tank from bottom to top , \* Steel patch bolted onto tank with layer of Belzona , \* Another view of the steel patch , \* View of additional steel patch at foot of the vessel ,

This vessel is a vital part of the plant and a complete failure would cause the entire unit to be shut down. The customer was producing \$5,000,000 in sales per week at that time and could not afford a failure. Belzona repair was completed in 1 day at a cost of around \$10,000, Belzona enabled the unit to stay in service until the January 2009 turnaround, when tank could be replaced.
