# BELZONA PROVIDES SOLUTION TO WATER INJECTION PUMP

ID: 122

Industry: Sugar  
Application: CEP-Centrifugal Pumps  
Substrate: Cast Iron  
Products: \* Belzona® 1311 (Ceramic R- Metal) ,  
\* Belzona® 1321 (Ceramic S-Metal) ,

Customer Location: Sugar Cane Mill in Australia  
Application Date: 1996

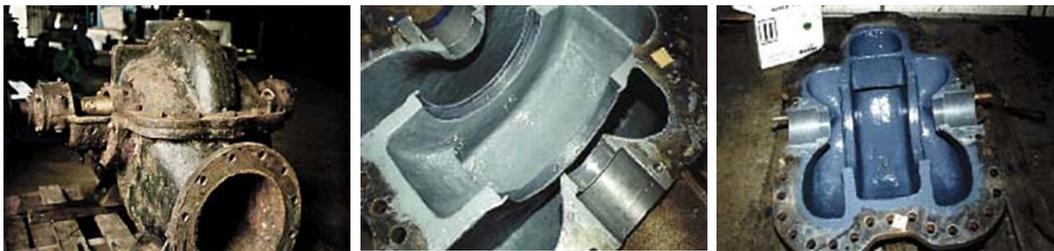
General erosion/corrosion on pump volute, wear ring seats and stuffing box

- \* Split casing water injection pump. ,
- \* Rebuilt wear ring seat and stuffing box. ,
- \* Completely refurbished casing. ,

The application was carried out in accordance with Belzona Know-How Leaflets CEP-1, CEP-2 and CEP-3.
