# TRANSFORMER LEAKS SEALED WITH BELZONA

Customer Location: Power Plant, West Tennessee U.S.A.

Application Date: 2006

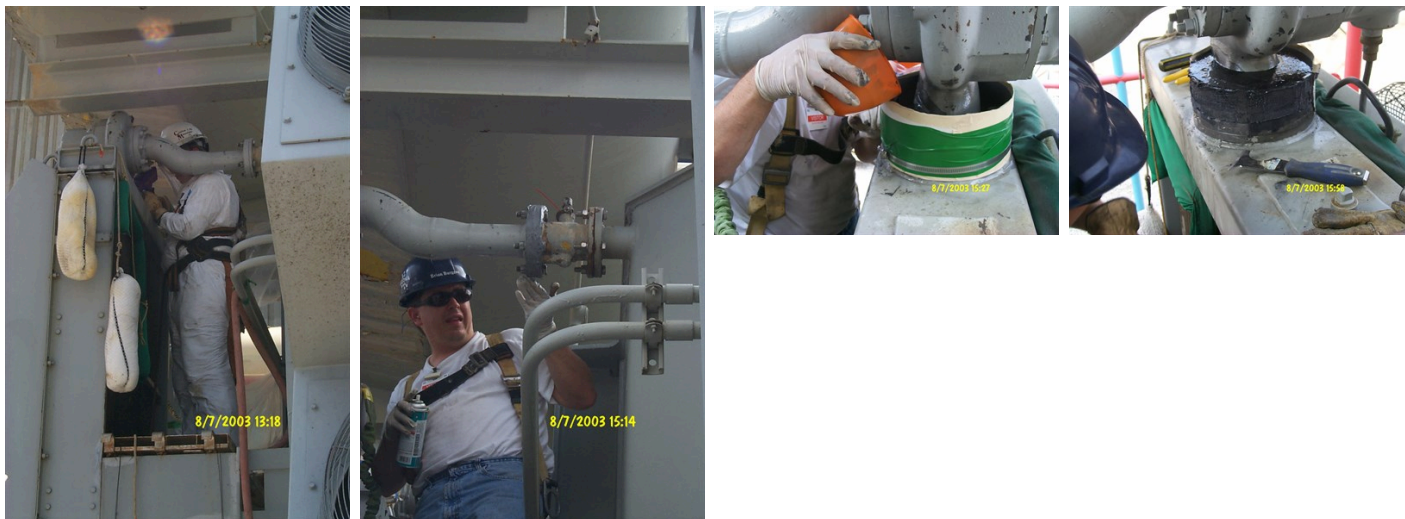
Oil leaks creating an environmental hazard. Transformers could not be drained for repair.

\* Overview of the area , \* Stopping the leak with Belzona® 1161 , \* Pouring Belzona® 2221 into the mold , \* Final view of cured Belzona ,

Transformers were leaking oil at the flanges.

Application was carried out using a modified Belzona Know-How System Leaflet GSS-4. Leak was temporarily stopped with Belzona® 1161. Mold then created around the flanges and Belzona® 2221 poured into the mold to completely encapsulate the flange.
