TRANSFORMER LEAKS SEALED WITH BELZONA

ID: 1221

Customer Location: Power Plant, West Tennessee U.S.A.

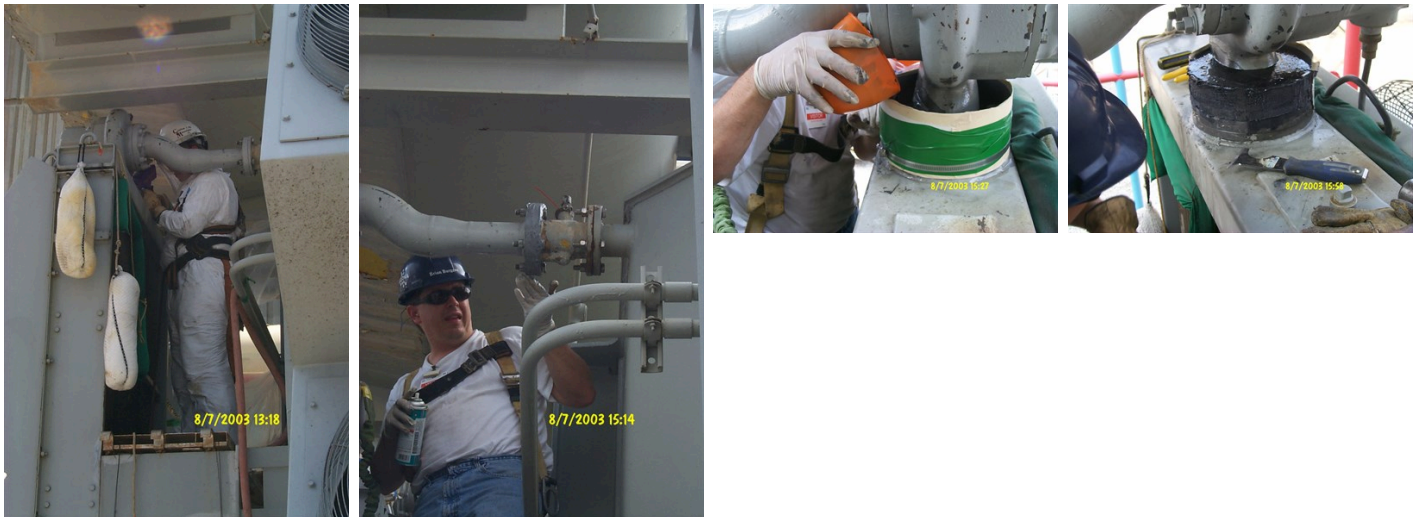
Photograph Descriptions

* Overview of the area , * Stopping the leak with Belzona® 1161 , * Pouring Belzona® 2221 into the mold , * Final view of cured Belzona ,

Transformers were leaking oil at the flanges.

Application was carried out using a modified Belzona Know-How System Leaflet GSS-4. Leak was temporarily stopped with Belzona® 1161. Mold then created around the flanges and Belzona® 2221 poured into the mold to completely encapsulate the flange.
