# COOLING TOWER REFURBISHED WITH BELZONA

ID: 1223

**Customer Location:** Hospital, Memphis Tennessee USA  
**Application Date:** 2008

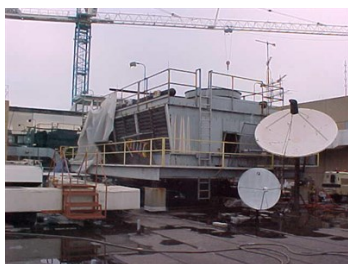
\* Cooling Tower overview , \* Blasting the Cold Water Basin , \* Belzona® 3121 over the seams , \* Final coat of Belzona® 5811 ,

Cooling Tower with severe corrosion in cold water basins
