COOLING TOWER REFURBISHED WITH BELZONA

ID: 1223

Customer Location: Hospital, Memphis Tennessee USA

Application: TCC-Tanks and Chemical Containment Areas

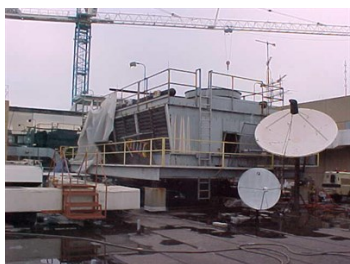
* Cooling Tower overview , * Blasting the Cold Water Basin , * Belzona® 3121 over the seams , * Final coat of Belzona® 5811 ,

Cooling Tower with severe corrosion in cold water basins
