BELZONA SEALS CONCRETE COOLING TOWER BASINS

ID: 1224

Customer Location: Chemical Plant, West Tennessee USA

Application: HEX-Heat Exchangers

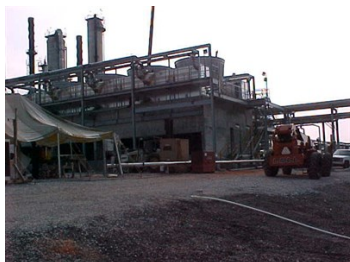
* Cooling Tower overview , * Walls repaired with Belzona® 4111 , * First coat of Belzona 5811 being applied , * Final Coat of Belzona 5811 applied ,

Concrete Basins in cooling tower were leaking shortly after the start up of a new unit.
