BELZONA CREATES PERFECT FIT FOR CRUSHER BUSHING

Industry: *Mining & Quarrying*
Application: *MPT-Mechanical Power Transmission*

Customer Location: *Lead Mine, Central Missouri USA*
Application Date: *May, 2008*

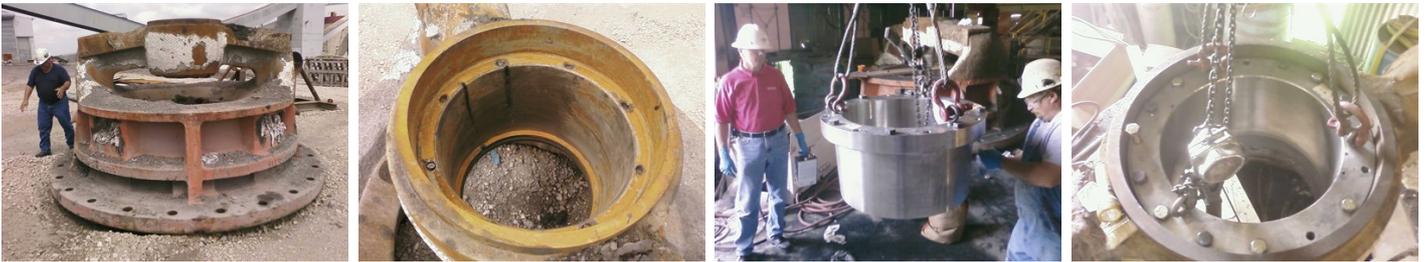
Photograph Descriptions

Upper Crusher Bushing seized on crusher shaft and spun inside the housing, resulting in loss of approximately .025" to the inner diameter. Housing suffered additional damage from cutting torch while removing old bushing.

* Upper Crusher Assembly (note size and weight) Damage to housing I.D and flange surface Release Agent being applied to new bushing New bushing lowered in place with jacking bolts used to position bushing ,

Application was carried out in accordance with Belzona Know How System Leaflet MPT-7. Belzona® 1111 was used to fill grooves cut by welding torch and Belzona® 1321 to restore inner diameter tolerances using the new bushing re-form the housing.
