BELZONA CREATES PERFECT FIT FOR CRUSHER BUSHING

Industry: Mining & Quarrying

Application: MPT-Mechanical Power Transmission

Customer Location: Lead Mine, Central Missouri USA

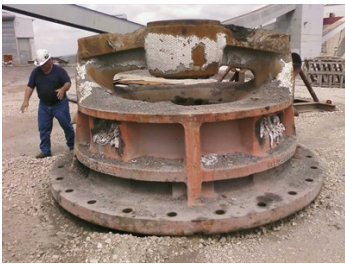
* Upper Crusher Assembly (note size and weight) Damage to housing I.D and flange surface Release Agent being applied to new bushing New bushing lowered in place with jacking bolts used to position bushing ,

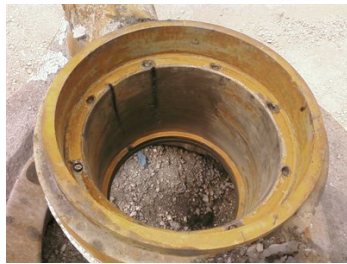
Upper Crusher Bushing seized on crusher shaft and spun inside the housing, resulting in loss of approximately .025" to the inner diameter. Housing suffered additional damage from cutting torch while removing old bushing.

Application was carried out in accordance with Belzona Know How System Leaflet MPT-7. Belzona® 1111 was used to fill grooves cut by welding torch and Belzona® 1321 to restore inner diameter tolerances using the new bushing re-form the housing.
