BELZONA REFURBISHES RUBBER-LINED PUMP

Application: SHM-Solids Handling Machinery

Customer Location: Sugar Cane Mill in Texas, U.S.A.

Ash slurry pump

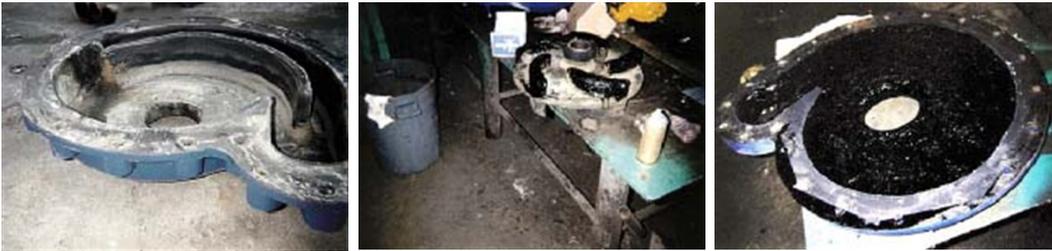
Photograph Descriptions

Pump casing and impeller suffer from erosion/corrosion due to the abrasive nature of the ash slurry.

- * View of uncoated casing. ,
- * Application of coating material to impeller. ,
- * Casing completely coated with Belzona® 2000 Series product. ,

The application was carried out in accordance with a modified version of Belzona Know-How Leaflet SHM-9.

The Belzona® 2000 Series Elastomeric Polymers afforded the casing with the necessary protection against abrasion and impact.
