# BELZONA REPAIRS POWER PLANT COAL BELT

ID: 1233

Customer Location: Power Station, Memphis, Tennessee  
U.S.A.

Application: SHM-Solids Handling Machinery

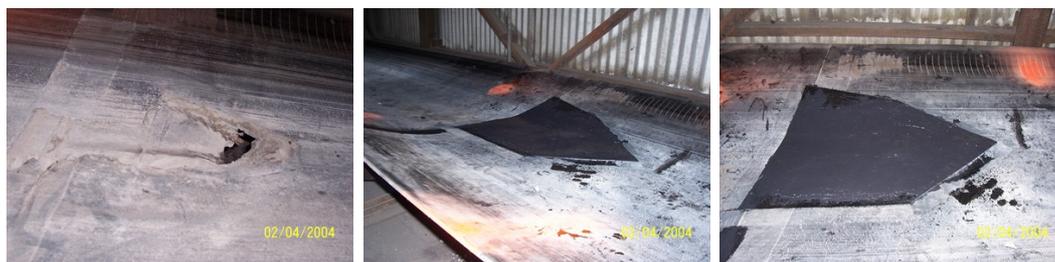
## Photograph Descriptions

After years of use the belt had developed several holes. If the holes were not taken care of it could cause ripping of the belt. prior to Belzona it would take up to a day for previous repair methods.

\* Damaged belt prior to repair , \* & 3. Repaired belt ,

Application was carried out in accordance with Belzona Know-How System Leaflet SHM-1.

This repair took less than an hour from start to finish. Previous repair methods took up to a day. This saved thousands of dollars in down-time.
