BELZONA EMERGENCY SHAFT REPAIR AT PULP & PAPER FACILITY

ID: 1235

Industry: *Pulp & Paper*

Products: *Belzona® 1221 (Super E Metal)*

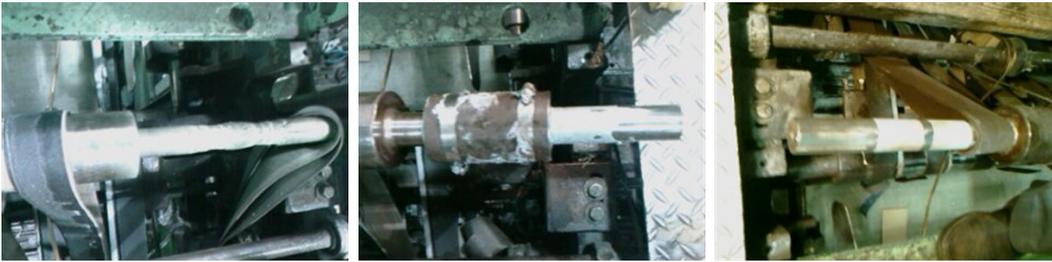
A bearing had run dry of lubrication and caused the entire line to shut-down.

* Shaft prior to repair , * Shaft during repair with former in place , * Shaft after repair ,

Shaft on the Primary paper machine.

Application was carried out in accordance with Belzona Know-How System leaflet MPT-2.

This roller was a critical in the operation of the plant. With this machine down the entire facility went down. The repair was performed during the lunch hour, saving thousands of dollars in down-time.
