# BELZONA EMERGENCY SHAFT REPAIR AT PULP & PAPER FACILITY

ID: 1235

Application: *MPT-Mechanical Power Transmission*

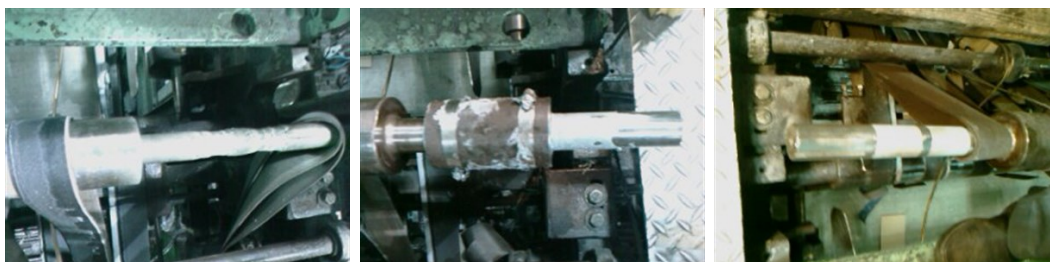
## Photograph Descriptions

*A bearing had run dry of lubrication and caused the entire line to shut-down.*

\* Shaft prior to repair , \* Shaft during repair with former in place , \* Shaft after repair ,

Application was carried out in accordance with Belzona Know-How System leaflet MPT-2.

This roller was a critical in the operation of the plant. With this machine down the entire facility went down. The repair was performed during the lunch hour, saving thousands of dollars in down-time.
