# BELZONA REPAIRS CORN WEAR

ID: 1237

Application: SHM-Solids Handling Machinery

Customer Location: Corn Processing Plant, West Tennessee

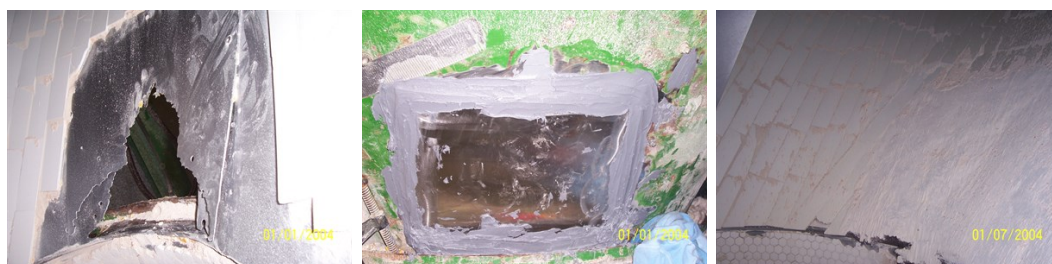
Ceramic tiles had fallen out of the vacuum system exposing the Stainless steel substrate. The corn being pulled through system quickly wore a hole through the steel causing loss of vacuum and stoppage of the unloading facility.

- \* The hole in the Vacuum system prior to repair ,
- \* External repair of hole with Belzona® 1221 bonded plate ,
- \* Internal repair with Belzona® 1812 applied ,

Application was carried out in accordance with Belzona Know-How System Leaflet SHM-13. A metal plate was bonded to the exterior with Belzona® 1221 prior to rebuilding the lost tile areas with Belzona® 1812.
